FARMINGTON RIVER BASIN
BURLINGTON CONNECTICUT

WHIGVILLE RESERVOIR DAM
CT-00379

PHASE I INSPECTION REPORT
NATIONAL DAM INSPECTION PROGRAM

FEBRUARY 1980

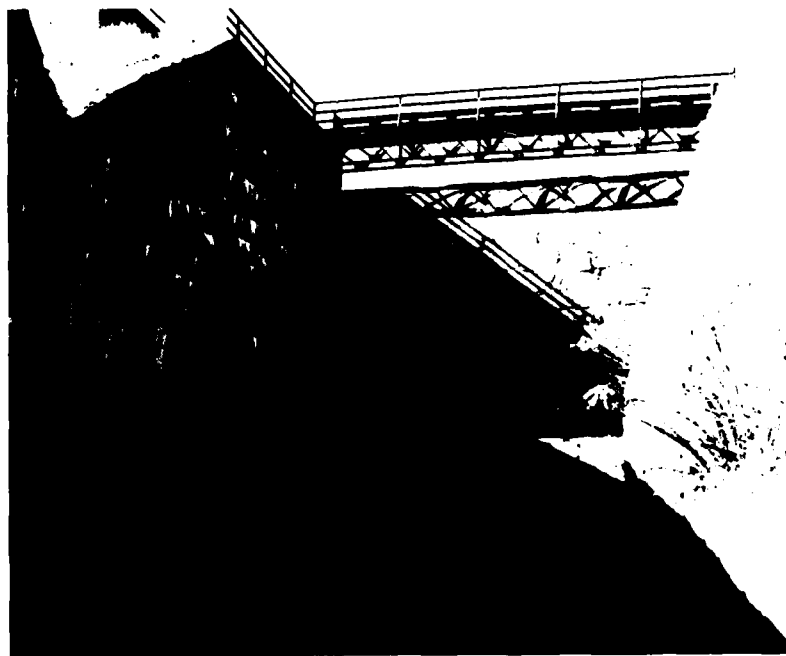
The nearly vertical downstream face of the spillway is generally in good condition, although there are numerous minor leaks and seepage noted at the joints (see photo No. 10).

f. Service Bridge. The foot bridge over the spillway is in good condition (photo No. 10). Some rusting of the steel members is taking place.

PHOTO #10: Spillway and service bridge.

b. Investigate the seepage through the joints in the stone masonry wing walls and recommend measures for repair to prevent erosion and piping of the embankment soils.

9) Paint steel members of footbridge to prevent continued rusting.
